**Flood Control Project Maintenance  
Levee Inspections**

**Fall 2010 Levee Maintenance Deficiency Summary Report**

**Reclamation District No. 2064 River Junction**

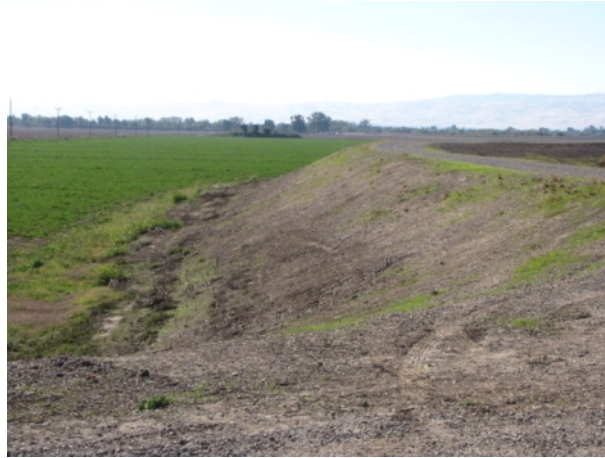
Levee Mile Report Line	1
Start Levee Mile	0.00
End Levee Mile	0.00
Location	Land Side
Category	Earthen Levee
Item	Vegetation

LMR No.	Levee Mile		Category	Item	* Location	** Rating	Action/Comment	GPS Latitude/Longitude		Issue No.
	Start	End						Start	End	Photo
1	0.00	0.00	Earthen Levee	Vegetation	LS	A	Control annual grass and weeds on the levee slopes and easements.	37.689963 ° -121.269692 °	37.689963 ° -121.269692 °	12 Y
2	0.71	0.71	Earthen Levee	Trim / Thin Trees	WS	C	Tree stumps.	37.702087 ° -121.271542 °	37.702087 ° -121.271542 °	10
3	2.43	2.43	Earthen Levee	Trim / Thin Trees	WS	N	Tree stumps.	37.688097 ° -121.257790 °	37.688097 ° -121.257790 °	4 Y
4	3.29	3.29	Earthen Levee	Trim / Thin Trees	LS	N	Tree stumps.	37.672717 ° -121.242518 °	37.672717 ° -121.242518 °	1 Y
5	3.53	3.53	Earthen Levee	Trim / Thin Trees	WS	N	Tree stumps.	37.677080 ° -121.264268 °	37.677045 ° -121.264263 °	5 Y
6	3.55	3.55	Earthen Levee	Trim / Thin Trees	LS	N	Tree stumps.	37.676801 ° -121.264203 °	37.676801 ° -121.264203 °	2 Y
7	3.66	3.66	Earthen Levee	Trim / Thin Trees	LS	N	Tree stumps.	37.675379 ° -121.263555 °	37.675379 ° -121.263555 °	3 Y

Standing on Landside from Levee mile 0.00 looking downstream of Unit 1 RD 2064. The District has done a great job maintaining the levee slopes. 11-12-2010

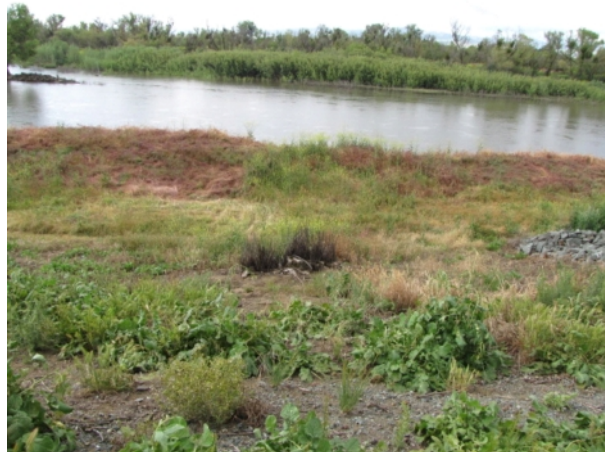
Levee Mile Report Line	3
Start Levee Mile	2.43
End Levee Mile	2.43
Location	Water Side
Category	Earthen Levee
Item	Trim / Thin Trees

Levee mile 2.43

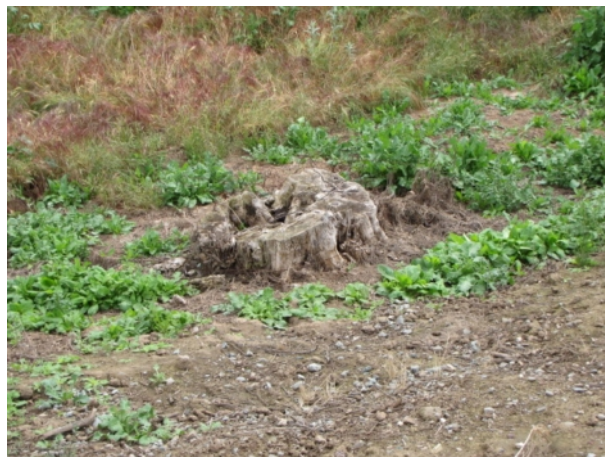
Levee Mile Report Line	4
Start Levee Mile	3.29
End Levee Mile	3.29
Location	Land Side
Category	Earthen Levee
Item	Trim / Thin Trees

Levee mile 3.29 land side toe.

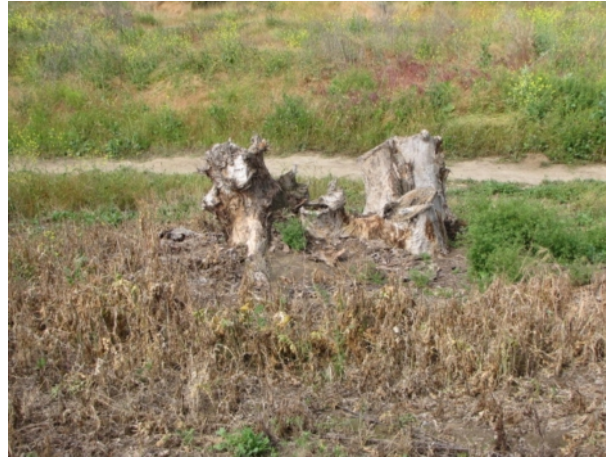
Levee Mile Report Line	5
Start Levee Mile	3.53
End Levee Mile	3.53
Location	Water Side
Category	Earthen Levee
Item	Trim / Thin Trees

Levee mile 3.53

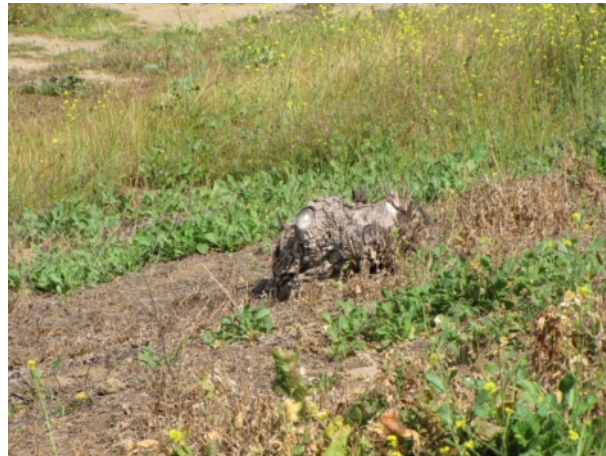
Levee Mile Report Line	6
Start Levee Mile	3.55
End Levee Mile	3.55
Location	Land Side
Category	Earthen Levee
Item	Trim / Thin Trees

levee mile 3.55

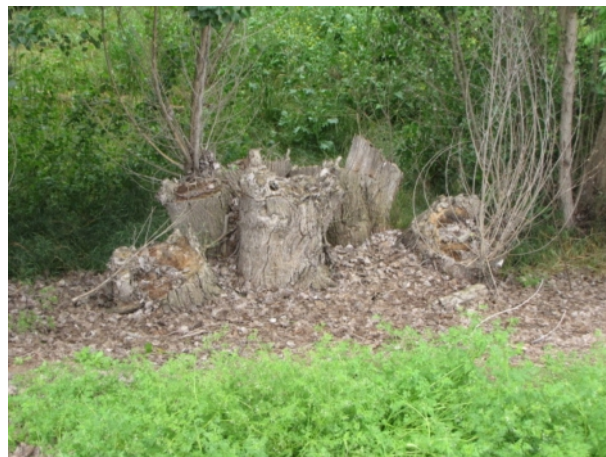
Levee Mile Report Line	7
Start Levee Mile	3.66
End Levee Mile	3.66
Location	Land Side
Category	Earthen Levee
Item	Trim / Thin Trees

Levee mile 3.66 waterward toe.

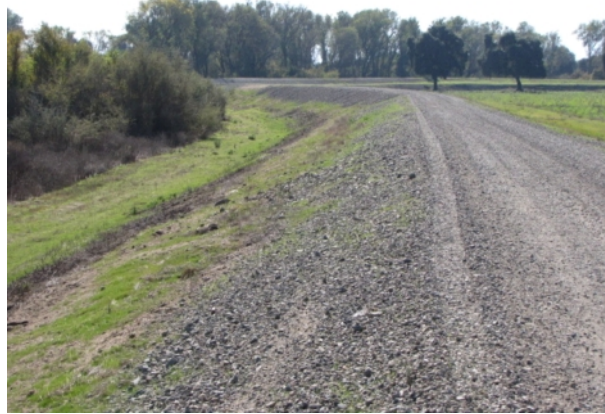
Levee Mile Report Line	2
Start Levee Mile	0.92
End Levee Mile	0.92
Location	Water Side
Category	Earthen Levee
Item	Vegetation

RD 2064 Looking upstream of levee mile 0.92  
Unit 2 waterside. 11-12-2010.

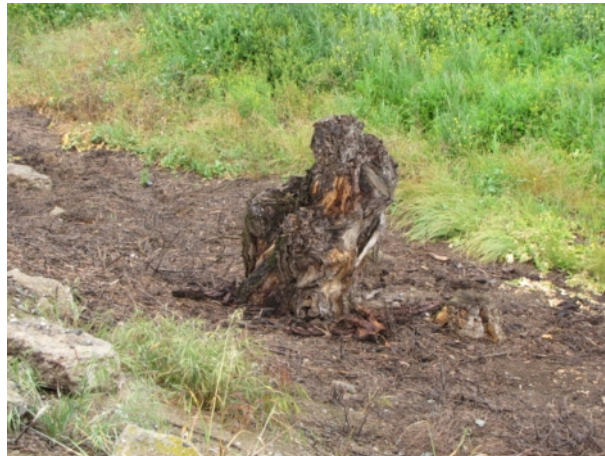
Levee Mile Report Line	3
Start Levee Mile	0.99
End Levee Mile	0.99
Location	Water Side
Category	Earthen Levee
Item	Trim / Thin Trees

levee mile 0.99

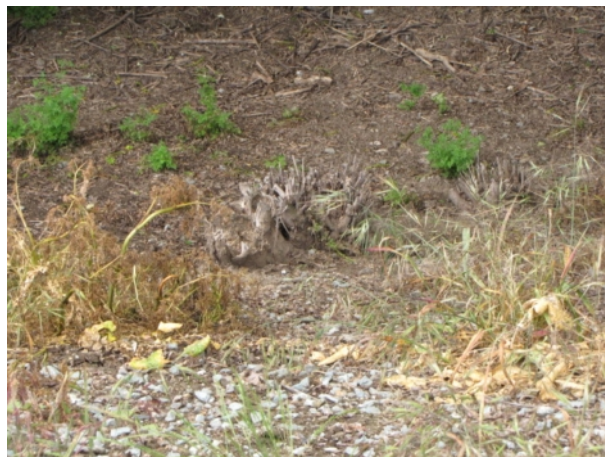
Levee Mile Report Line	5
Start Levee Mile	1.76
End Levee Mile	1.76
Location	Land Side
Category	Earthen Levee
Item	Trim / Thin Trees

levee mile 1.76

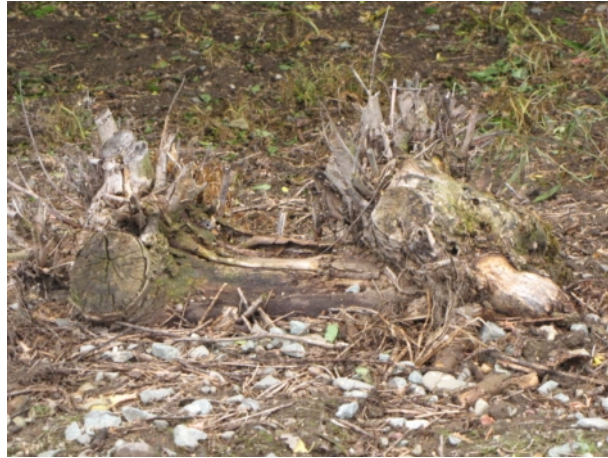
Levee Mile Report Line	6
Start Levee Mile	1.78
End Levee Mile	1.78
Location	Land Side
Category	Earthen Levee
Item	Trim / Thin Trees

6	1.78	1.78	Earthen Levee	Trim / Thin Trees	LS	N	Tree stumps.	37.673332 ° -121.222060 °	37.673332 ° -121.222060 °	5 Y
7	1.79	1.81	Earthen Levee	Trim / Thin Trees	LS	N	Tree stumps.	37.673455 ° -121.222167 °	37.673727 ° -121.222422 °	6 Y
8	1.86	1.86	Earthen Levee	Trim / Thin Trees	LS	N	Tree stumps.	37.674438 ° -121.222727 °	37.674438 ° -121.222727 °	7 Y
9	2.26	2.26	Earthen Levee	Trim / Thin Trees	WS	N	Tree stumps.	37.679930 ° -121.223220 °	37.679930 ° -121.223220 °	8 Y
10	2.27	2.27	Earthen Levee	Trim / Thin Trees	WS	N	Tree stumps.	37.679988 ° -121.223340 °	37.679988 ° -121.223340 °	9 Y
11	2.35	2.35	Earthen Levee	Trim / Thin Trees	WS	N	Tree stumps. Inspector Comments: This stump actually is off the toe waterward.	37.680025 ° -121.223783 °	37.680025 ° -121.223783 °	10 Y
12	3.09	3.09	Earthen Levee	Trim / Thin Trees	WS	N	Tree stumps.	37.687722 ° -121.217045 °	37.687722 ° -121.217045 °	11 Y
13	4.18	4.18	Earthen Levee	Trim / Thin Trees	LS	N	Tree stumps.	37.694172 ° -121.207255 °	37.694172 ° -121.207255 °	12 Y

levee mile 1.78

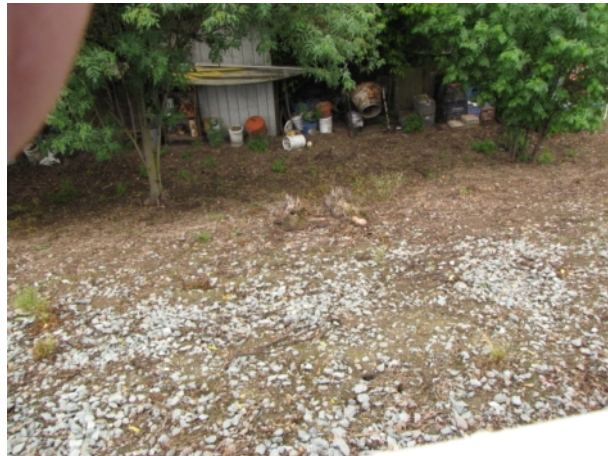
Levee Mile Report Line	7
Start Levee Mile	1.79
End Levee Mile	1.81
Location	Land Side
Category	Earthen Levee
Item	Trim / Thin Trees

levee miles 1.79-1.81

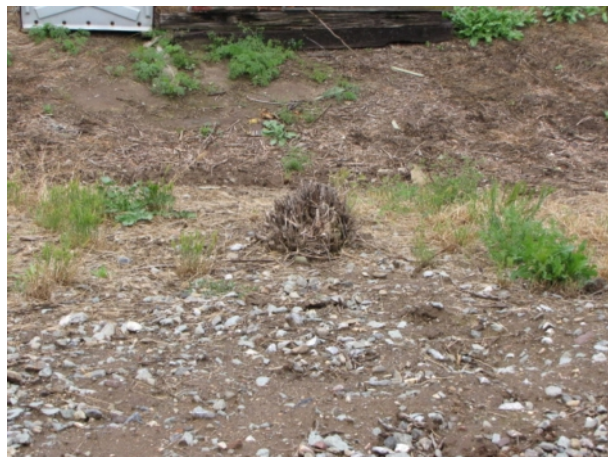
Levee Mile Report Line	8
Start Levee Mile	1.86
End Levee Mile	1.86
Location	Land Side
Category	Earthen Levee
Item	Trim / Thin Trees

Levee mile 1.86
